**PAWCATUCK RIVER BASIN
NORTH STONINGTON, CONNECTICUT**

**WYASSUP LAKE DAM
CT. 00570**

**PHASE 1 INSPECTION REPORT
NATIONAL DAM INSPECTION PROGRAM**

AUGUST, 1980

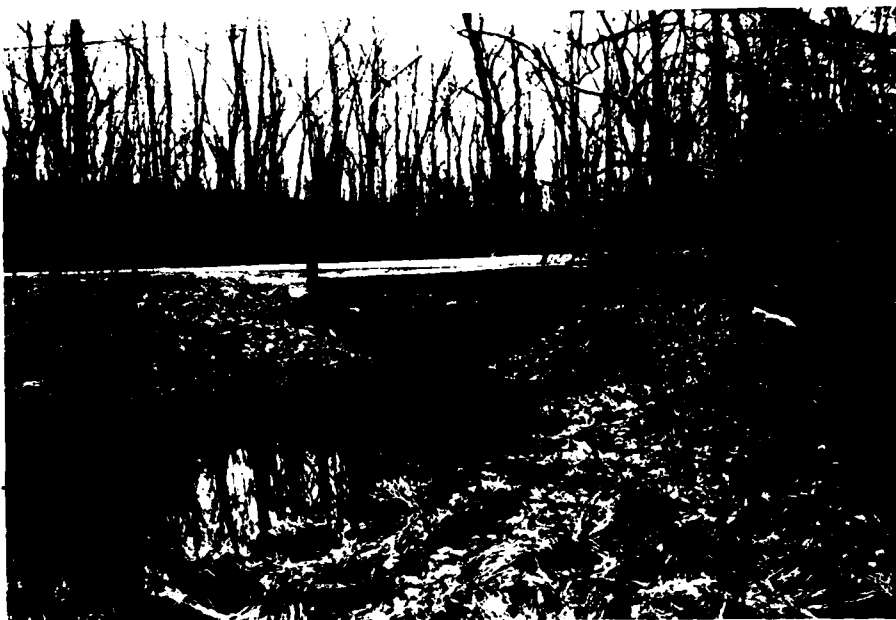
PHOTO C-13 Downstream culvert.

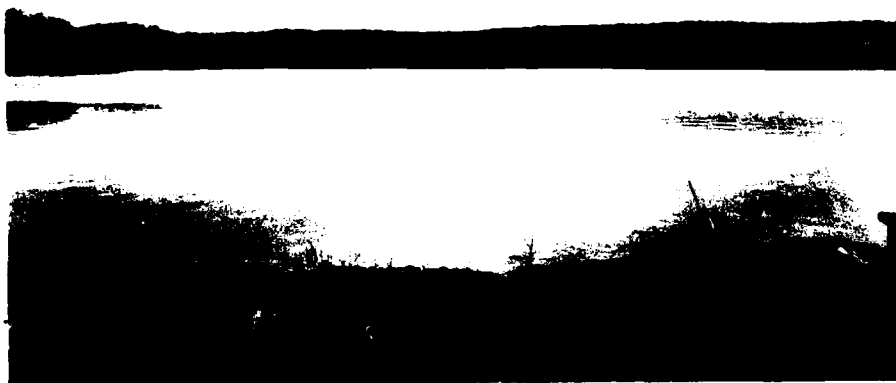
- d. Reservoir Area. The shoreline area of Wyassup Lake is flat to moderately sloped with vegetation and trees covering the banks. Floating debris could obstruct the overflow spillway, or more easily the downstream channel, causing localized flooding. No evidence of shoreline sloughing or severe bank erosion was observed. (See Photo C-14).

PHOTO C-14 Wyassup Lake.

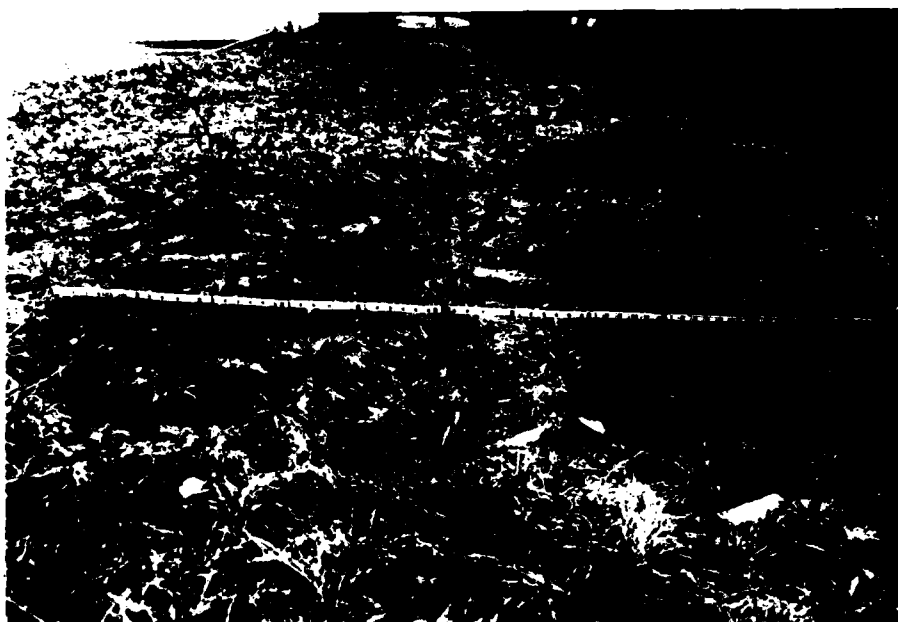
The crest of the left embankment is grass covered and generally in good condition. A shallow (up to 6 inches deep) depression 15 feet long and 2 feet wide was observed 6 feet from the downstream edge of the crest approximately 80 feet from the right abutment (Photo C-16). A second depression (up to 4 inches deep) approximately 5 feet long and 1 foot wide was observed 6 feet from the downstream edge of the crest approxi-

PHOTO C-16 Depression in crest at location of old masonry dam.

5. Investigate the cause of the depressions along the crest and take appropriate measures to correct it.
